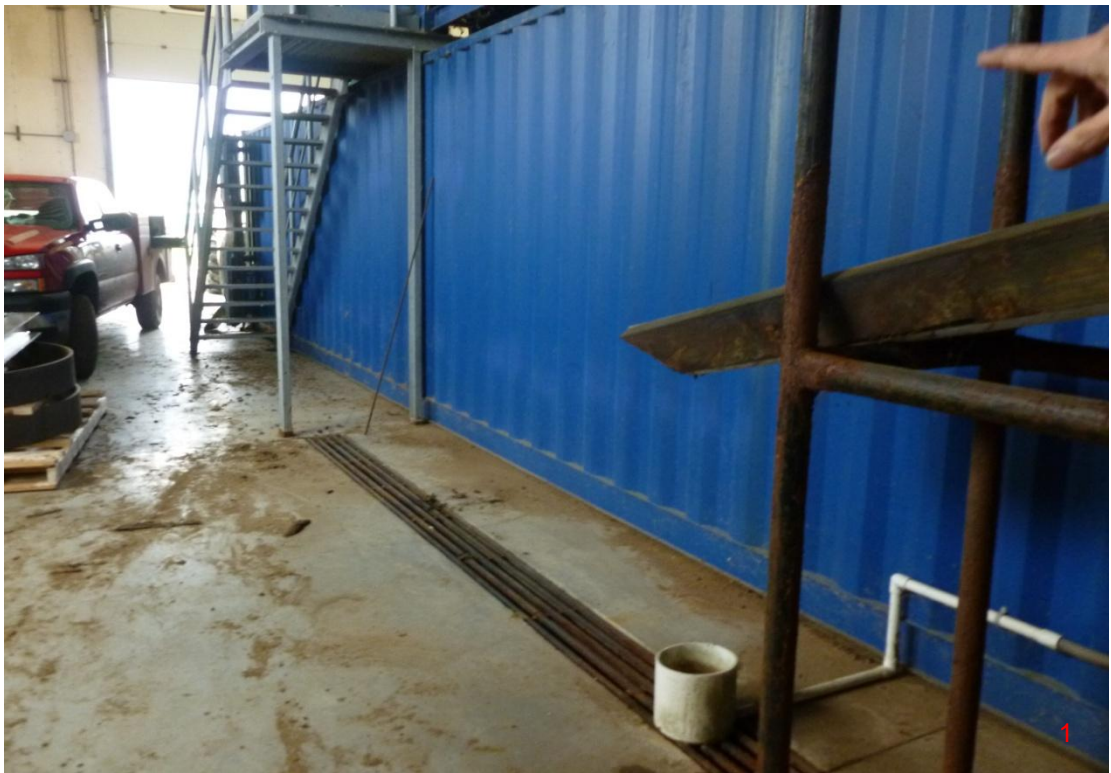
Picture 1 – Daona Farm, Shoreham, VT – 4/25/12  
Trench drain in bedding building for collecting condensate from the BRU unit.

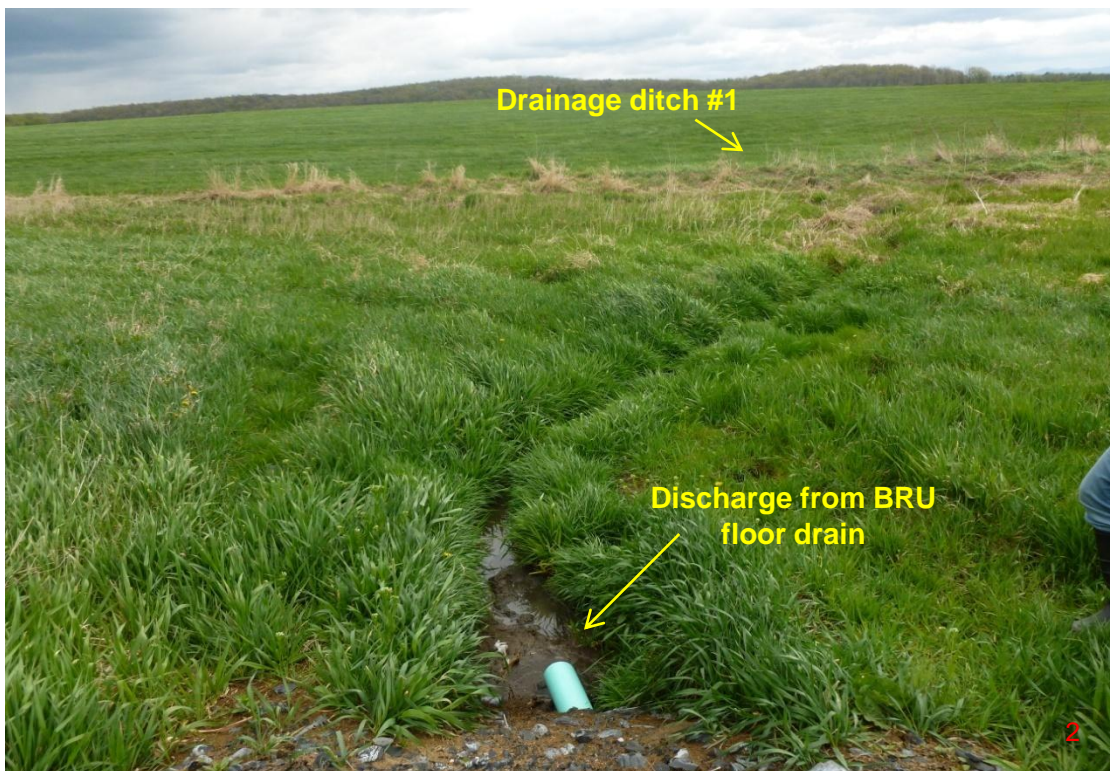
Picture 2 – Daona Farm, Shoreham, VT – 4/25/12  
Discharge pipe from floor trench drain in BRU building.

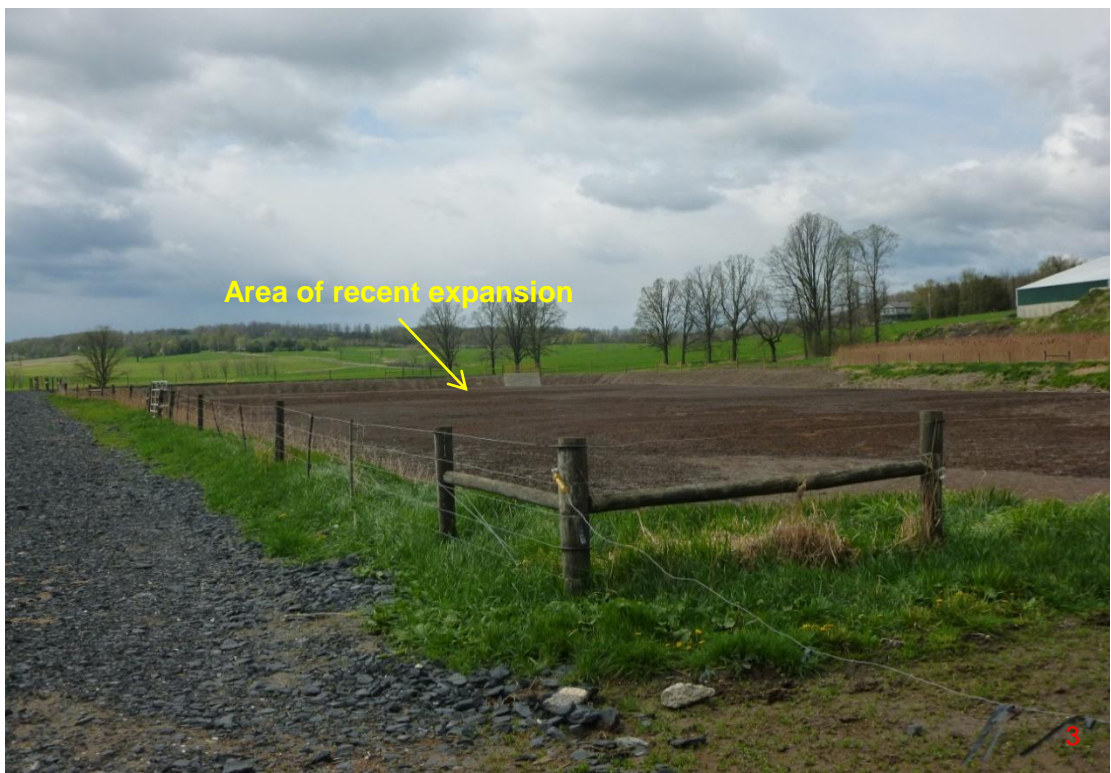
Picture 3 – Daona Farm, Shoreham, VT – 4/25/12  
Clay-lined manure pit, with additional capacity and new access ramp.

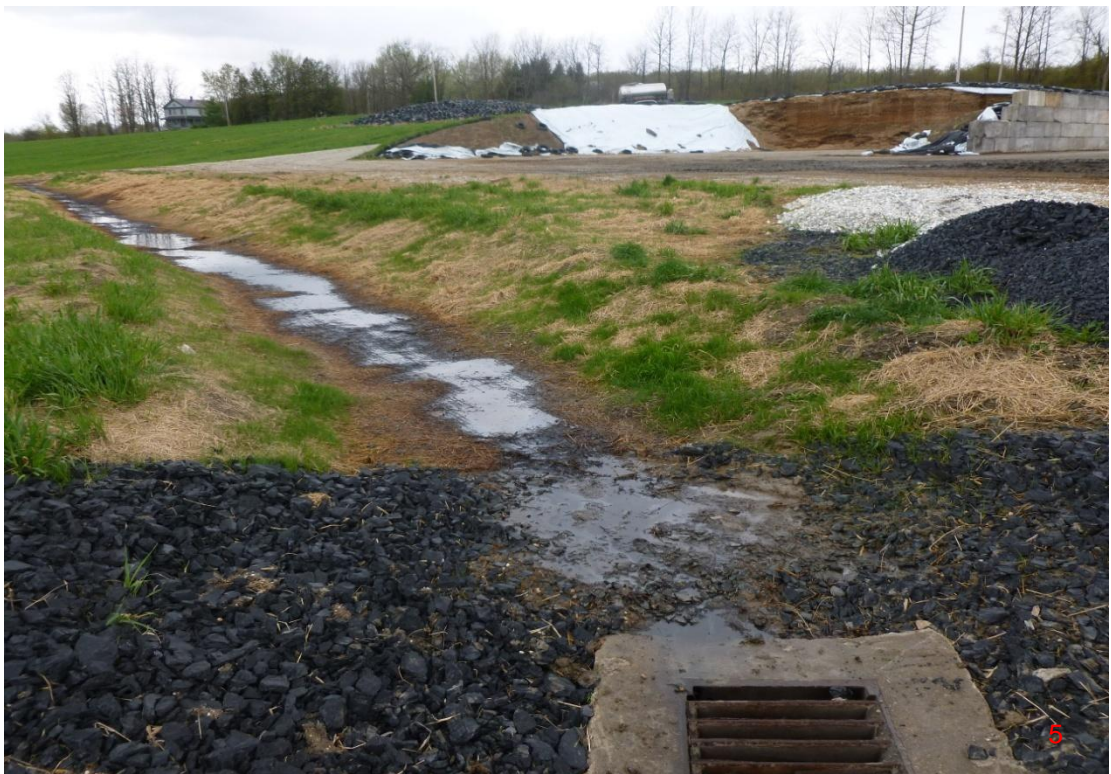
Picture 5 – Daona Farm, Shoreham, VT – 4/25/12  
New silage runoff collection system which splits flow to the manure pit and a gravel-lined path.

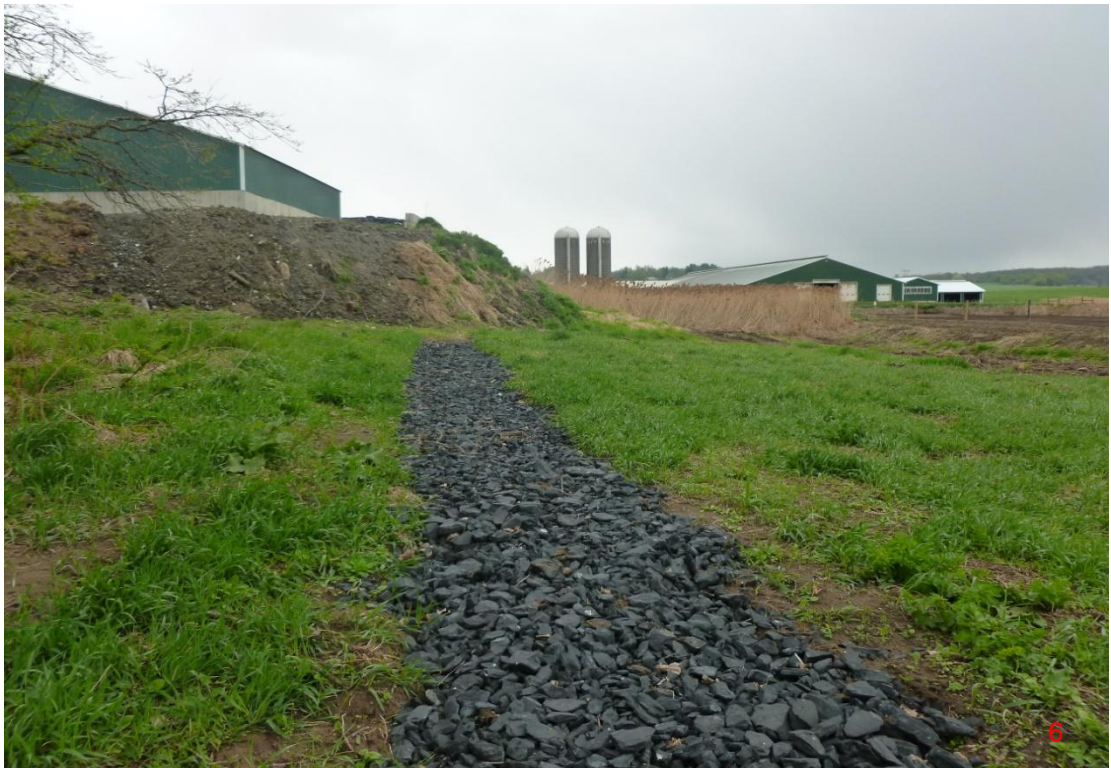
Picture 6 – Daona Farm, Shoreham, VT – 4/25/12  
Gravel-lined path which receives excess drainage from the new silage runoff collection system.

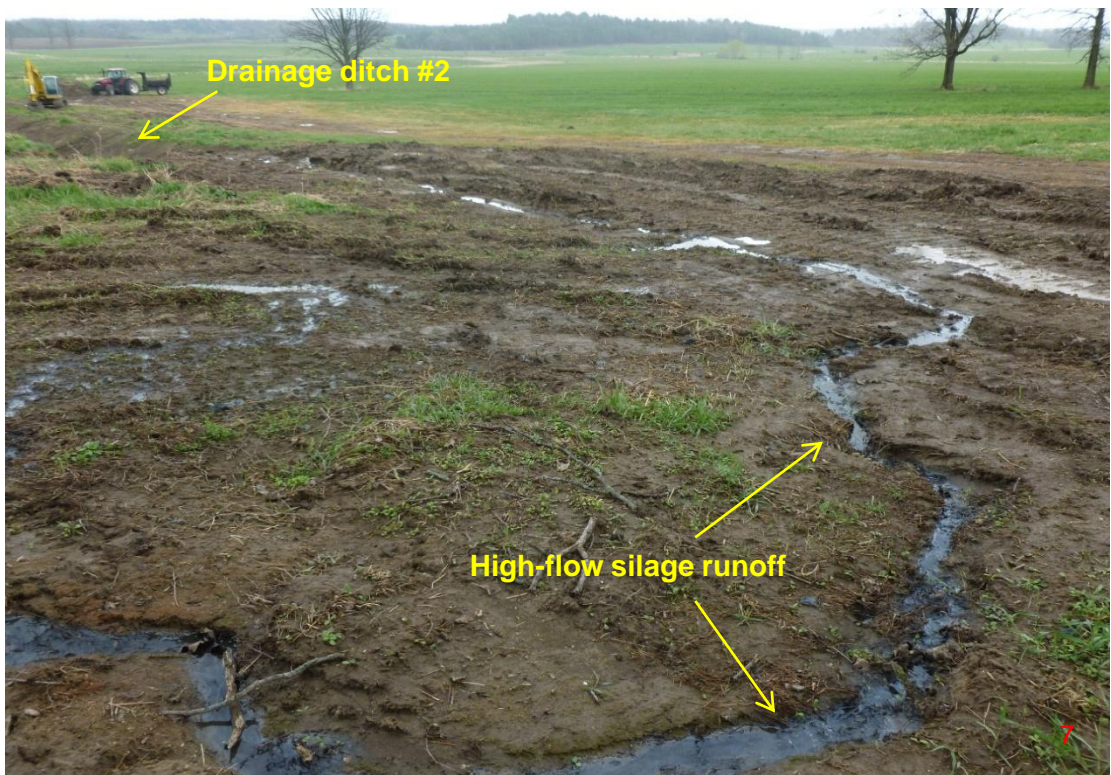
Picture #7 – Daona Farm, Shoreham, VT – 4/25/12  
Silage collection runoff from the gravel path (in picture #6 )flowing toward drainage ditch #2.

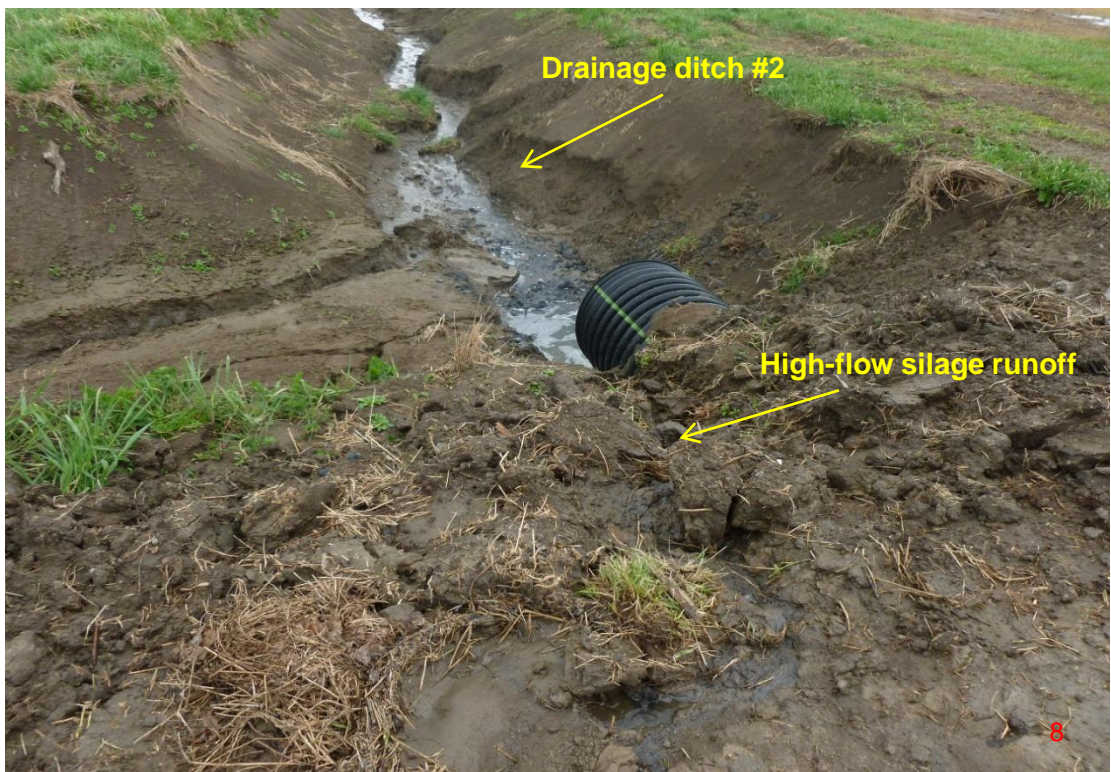
Picture #8 – Daona Farm, Shoreham, VT – 4/25/12  
Silage collection runoff flowing into drainage ditch #2.

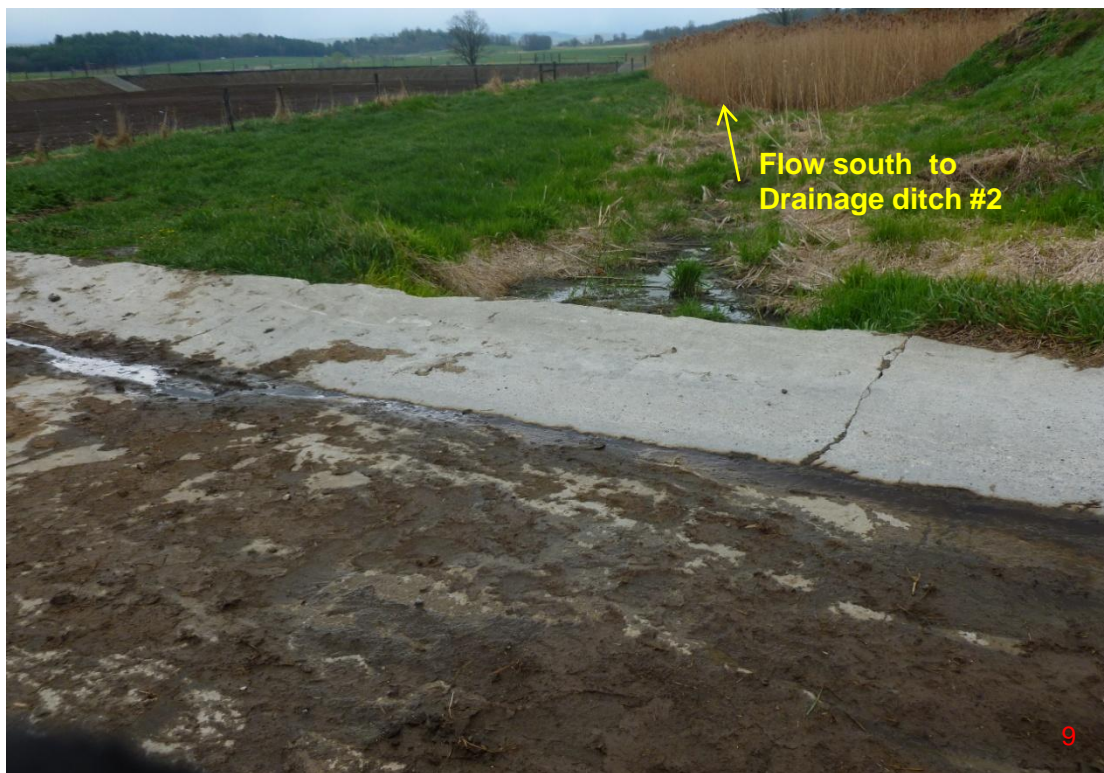
Picture #9 – Daona Farm, Shoreham, VT – 4/25/12  
Concrete spillway for runoff from the semi-solids pit to the manure pit.

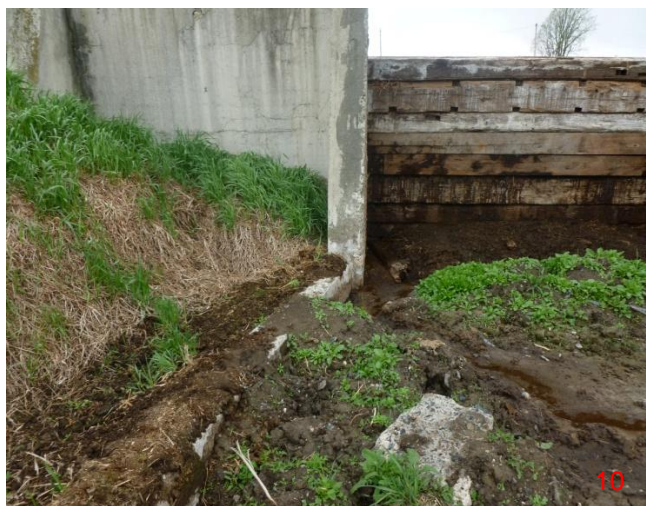
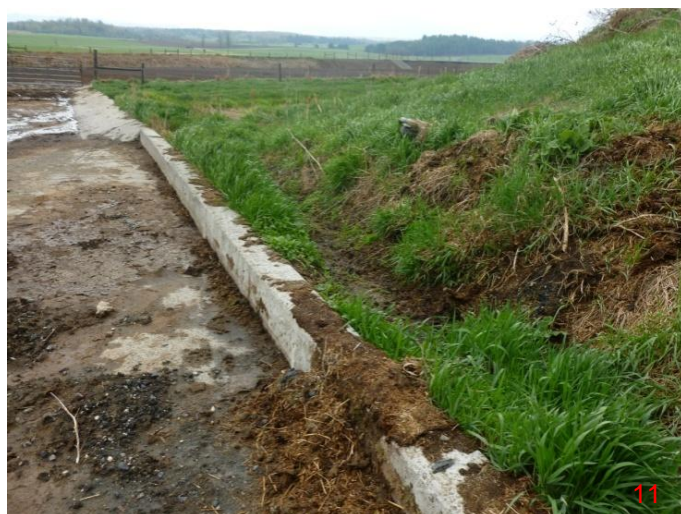
Pictures #10-11 – Daona Farm, Shoreham, VT – 4/25/12  
Solids overflowing berm of the concrete spillway between the semi-solids pit and the manure pit.

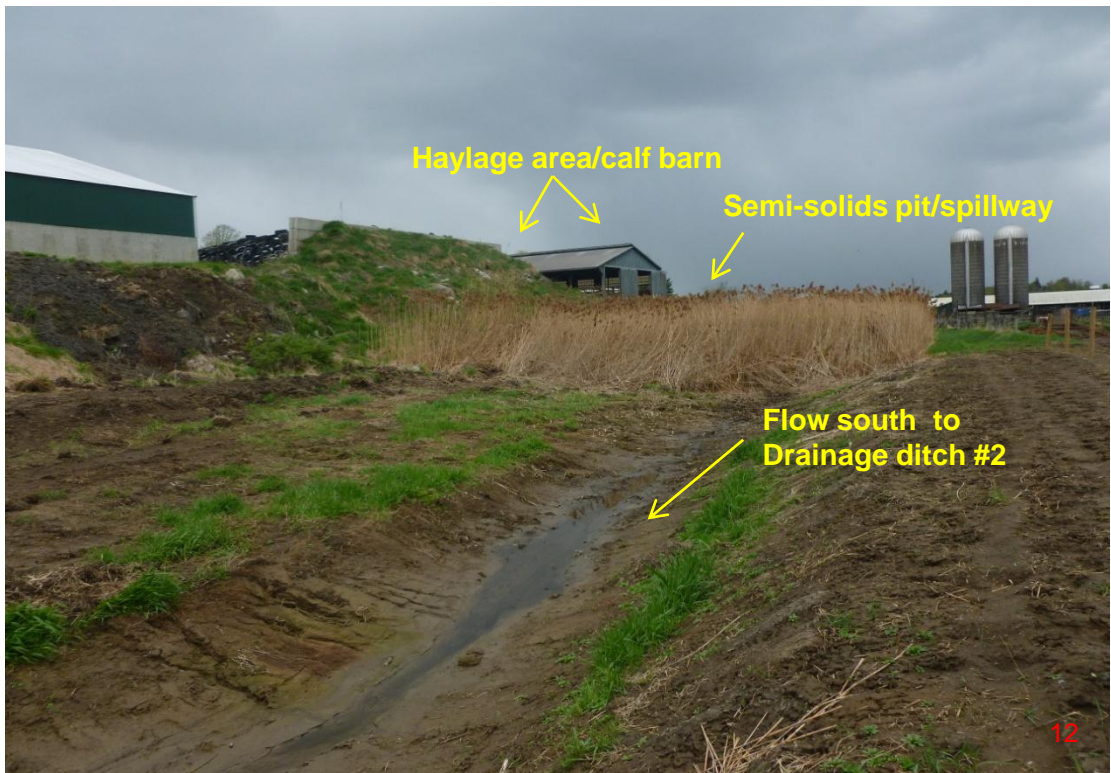
Picture #12 – Daona Farm, Shoreham, VT – 4/25/12  
Drainage swale for runoff from haylage storage and outside semi-solids pit spillway.

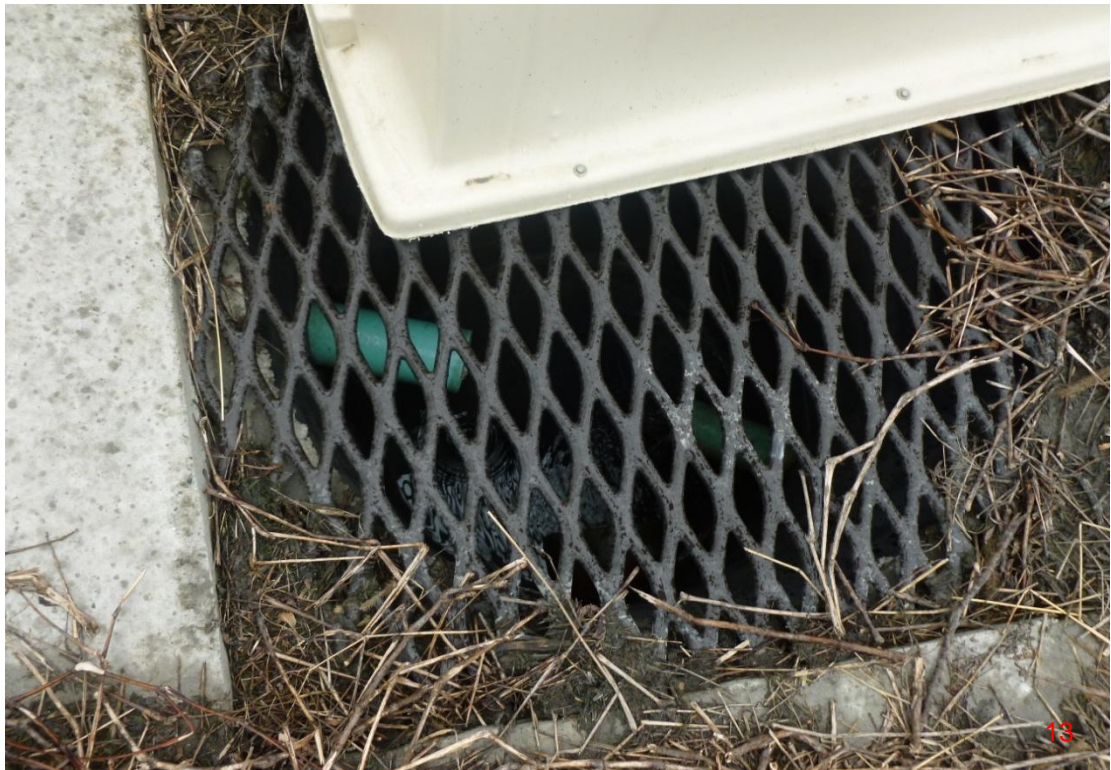
Picture #13 – Daona Farm, Shoreham, VT – 4/25/12  
Gray water wet well outside main barn with overflow pipe to drainage ditch #1.
